PRODUCT SERVICE DIVISION
TECHNICAL SERVICES DEPARTMENT
SERVICE BULLETIN

SB NO. **05958**

SUBJECT: **INTERMITTENT & NO-RUN UNITS**
UNIT(S): **COMPACT POWER - SEE BELOW**
DATE CODES: **9445 AND EARLIER**

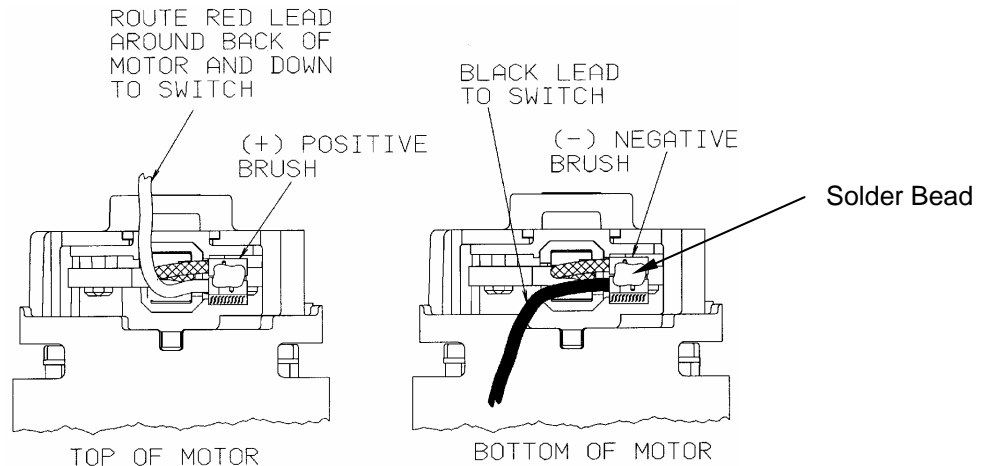
If there is no solder bead connecting the Brush Terminals, replace the Brush Box Assemblies with the part number shown in the chart. Each of the assemblies shown contains two complete Brush Holder Assemblies including Brushes and Leads. Test tool for proper operation.
